A comprehensive Analysis of Dewana Dam Spillway Failure: Causes, and Consequences

Avi Ari Salahadin^{1,a,*}

Kawa Zaidan Abdulrahman^{2,a}

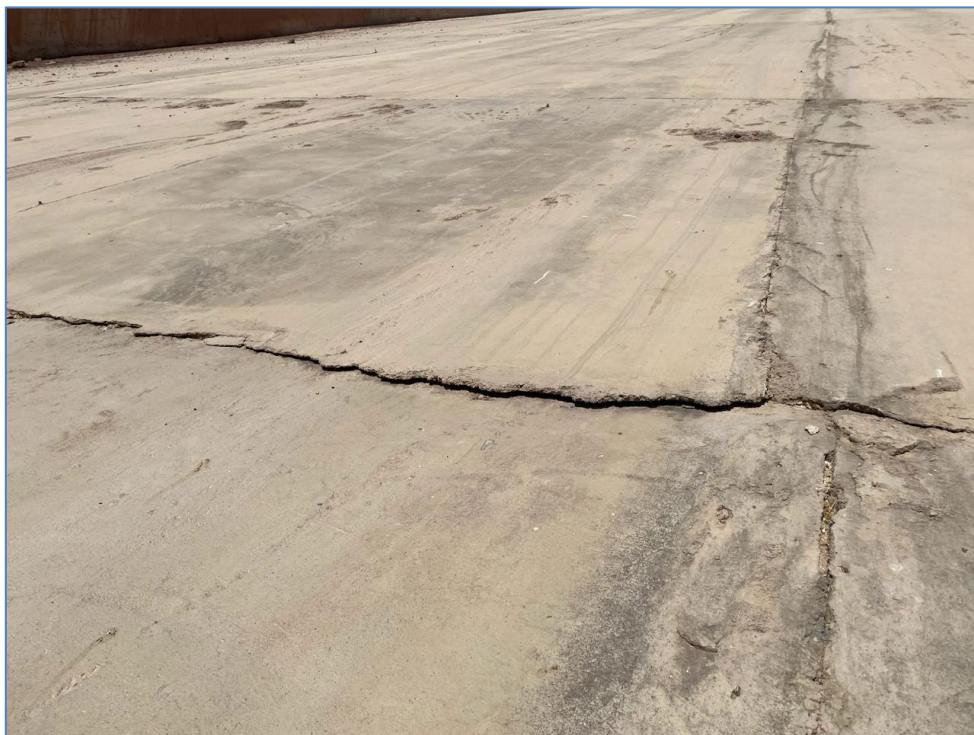
- Displacement and cracking patterns in the chute slabs.
- Uplifted concrete panels and joint separations.
- Exposed foundation rock quality and erosion features.
- Waterstop installation condition.
- Upstream key of the panels and their effectiveness. Figure 3 and Figure 4 are two photos for pre and post failure conditions; respectively.

Figure 3:Bad Joint Arrangement Just After Construction.

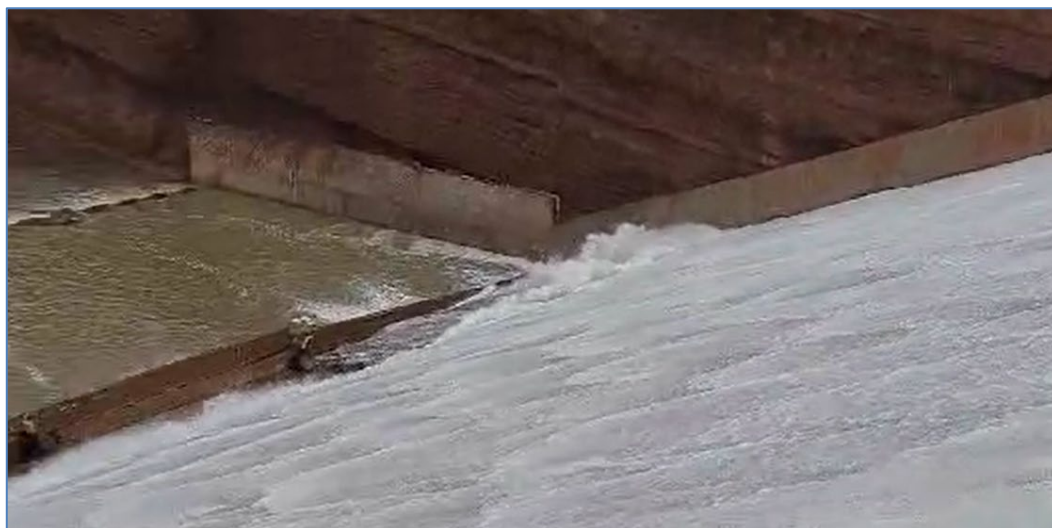
slightly higher peak discharge of around 200 m³/s caused significant structural damage to the chute spillway. Most notably, the chute slab near the stilling basin—located along the steepest section of the chute—experienced catastrophic failure. The slab broke, uplifted, and was displaced downstream, exposing the underlying low-quality foundation rock to direct high-velocity flow. This exposure initiated aggressive erosion processes, resulting in deep scour holes and further degradation of the structure. A key mechanism in such failures is flow-induced uplift pressure beneath spillway chute slabs, particularly in cases where slab joints are unvented or have poor drainage (ICOLD, 2015) (USBR, 2022). (Wahl et al., 2019) demonstrated that uplift pressures below chute slabs at unvented, open, offset joints can reach damaging levels during high-flow events, especially if foundation drainage is inadequate. Similarly, (Wahl

Figure 4:Photo Showing Some Displaced Panels.

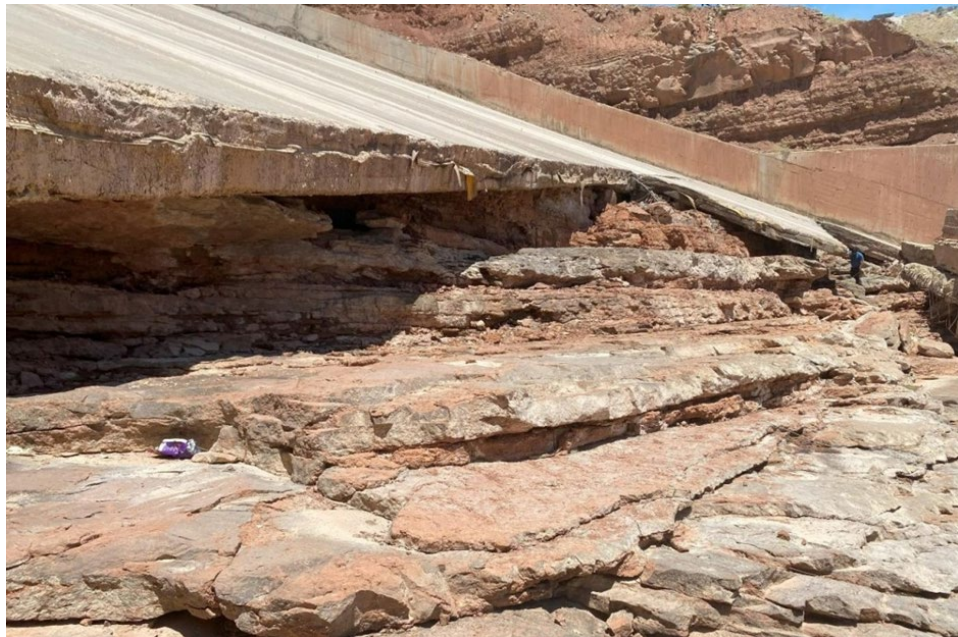
poor-quality bedrock. This substandard foundation material was highly susceptible to erosion. Over time, water infiltrating through cracks and inadequately sealed joints began to undermine the integrity of the subgrade. As the erosion progressed, it caused parts of the chute slab to crack and shift. The resulting gaps allowed even more water to enter and accelerate erosion within the foundation as shown in Figures 10 and 11. This process led to the displacement of slab sections, exposing the already weak bedrock to further degradation. Ultimately, the erosion reached a critical level, forming deep scours and severely compromising the structural integrity of the spillway. Another factor that may have contributed to the failure is the orientation of the bedding planes in the jointed rock foundation. The bedding planes were observed to be approximately parallel to the spillway chute slope, which could have facilitated the downslope movement of the concrete panels. This condition becomes particularly critical under the influence of stagnation pressure forces, which act parallel to the panel surface at locations where offsets or misalignments exist. Combined with the inherently weak shear strength of the bedrock, this geological configuration likely reduced the resistance to sliding and exacerbated panel instability during high-velocity flow events. The case might not be worsened like this if the bedding plane angle were perpendicular to the chute angle as shown in Figure 5.

Figure 5: Exposed foundation showing thin jointed beddings downstream.

foundations must be re-excavated or treated to restore strength and erosion resistance.

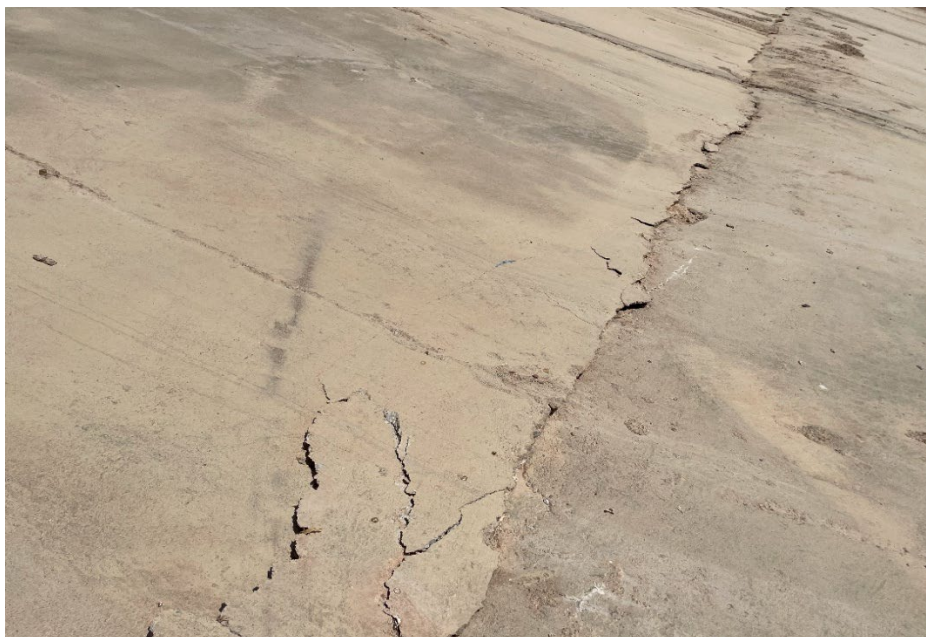
A key factor contributing to the initial distress observed on the chute floor was the presence of cracks, along with inadequate joint detailing and poor performance of waterstops. Evidence of cracking was observed shortly after the completion of construction, as shown in Figure 7, indicating potential issues related to early-age shrinkage, poor finishing, or insufficient curing. Figure 8 illustrates a substantial 10 cm vertical offset between adjacent panels, where no cushion was provided to control differential movement. Additionally, Figure 9 highlights improper waterstop installation, which allowed seepage along the joint line, increasing the risk of uplift pressure beneath the slabs. The combination of these deficiencies—cracking, joint misalignment, lack of cushioning, and ineffective seepage control—significantly undermined the structural integrity of the spillway chute and contributed to its eventual failure. In well-designed chute structures, a cushion is typically incorporated at the downstream end of a chute panel—specifically at the cutoff wall located at the upstream edge of the adjacent downstream panel—to provide structural support for the upstream panel edge. This detail plays a critical role in preventing differential movement between adjoining panels by distributing applied loads and maintained consistent contact under both static and dynamic hydraulic conditions. In the case of the Dewana Dam spillway, the absence of this cushion detail allowed adjacent panels to move independently, leading to vertical misalignments and the development of offsets within the flow path, which increased the susceptibility of the structure to hydraulic and structural failure. Moreover, the waterstops, which are critical for preventing seepage through joints, were either poorly installed or failed to maintain an adequate bond with the adjacent concrete panels. This created preferential seepage paths beneath the chute panels, promoting the development of uplift pressures and subsequent slab instability.

Figure 7: Cracks and bad joint finishing

- Joint systems must be fully embedded and properly detailed to prevent leakage and pressure buildup.
- Concrete slab integrity must be ensured through appropriate reinforcement, curing, and crack control measures.
- Geotechnical preparation must not be compromised by construction delays; weathered

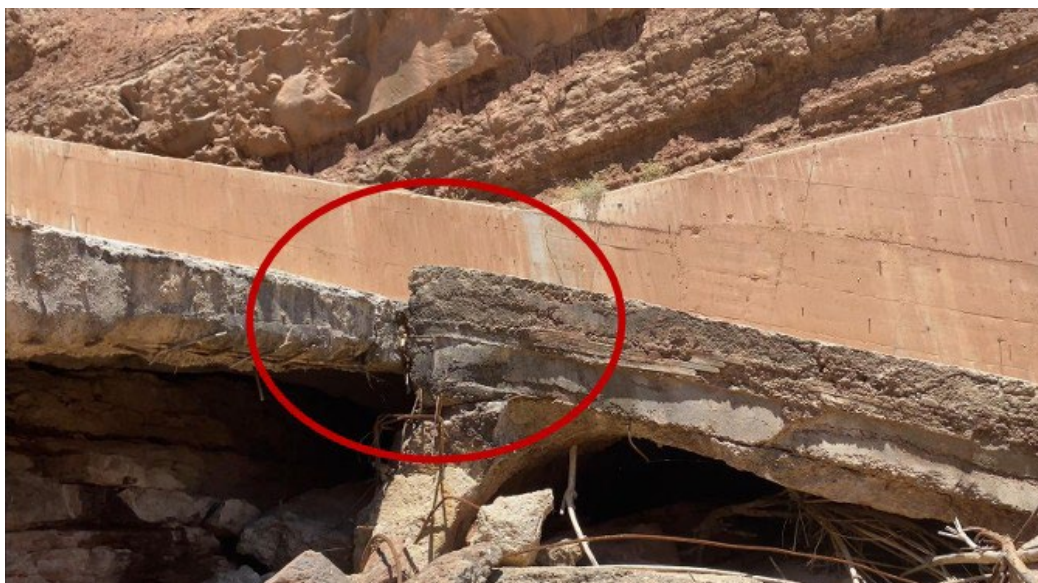
Prolonged water percolation beneath the chute panels led to progressive erosion of the underlying low-strength foundation material. The absence of a cushion at the cutoff key, which is typically used to prevent differential settlement, likely contributed to localized displacement between adjacent panels. This displacement may have created geometric offsets within the flow path. At such offsets, a stagnation zone forms where the high-velocity flow directly impinges on the upstream face of the discontinuity. In this region, the velocity head of the approaching flow is transformed into pressure head, generating stagnation pressure (Chow, 1959). This concentrated pressure can significantly increase uplift forces acting under the chute slabs, potentially leading to structural failure if not properly mitigated. When a discontinuity or opening exists within the slab joint, this stagnation pressure may be partially or fully transmitted through the joint, inducing uplift forces beneath the concrete slab (peterka, 1978). For high-velocity flow (flow over steep chutes), stagnation pressure can result in very high uplift pressures due to the conversion of the velocity head to a static head which can lead to slab uplifting (jacking) and removal of sections of the

Figure 8: Offset of the panel.

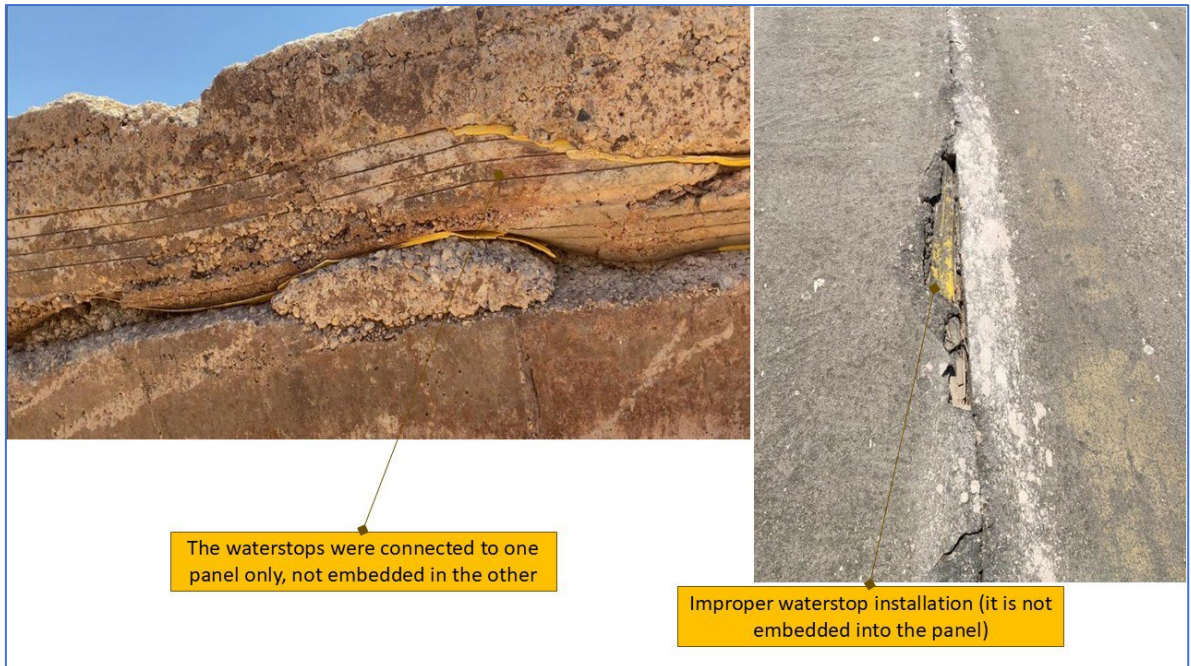
Figure 9: Improper waterstops installation.

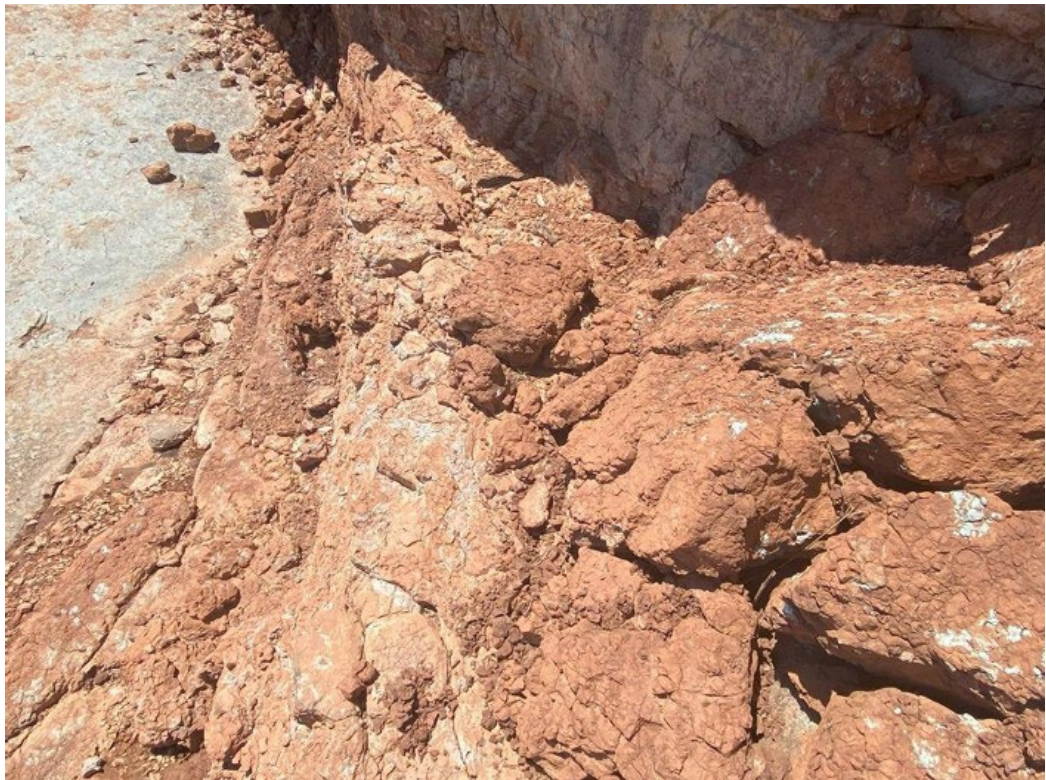
A geotechnical assessment was conducted to evaluate the foundation conditions beneath the damaged spillway slabs. Visual inspection of the exposed subgrade revealed significant erosion and material loss, particularly beneath the displaced slab sections. Erosional depths reached approximately 1.8 meters, indicating that the underlying rock was highly friable and of insufficient strength to withstand high-velocity flows and uplift pressures. To contextualize these findings, historical geotechnical investigation reports, borehole logs, and construction quality control records were reviewed. The data revealed a notable discrepancy between the originally assumed foundation conditions during design and the actual in-situ state at the time of failure. Further investigation revealed a key construction-phase deficiency: the spillway foundation excavation had been completed several years prior to slab placement but was left exposed to environmental weathering due to project funding delays. The exposed foundation—primarily composed of claystone and interbedded sandstone—underwent significant degradation over a four-year hiatus before construction resumed as shown in Figure 5 that has been taken from a reliable reference (Omed Yousif, 2024). Critically, the weathered and weakened surface layers were not adequately removed or reconditioned prior to concrete placement, resulting in a compromised bearing stratum with reduced erosion resistance.

Figure 10: Weathered rock beneath the chute slab of the Dewan Dam spillway.

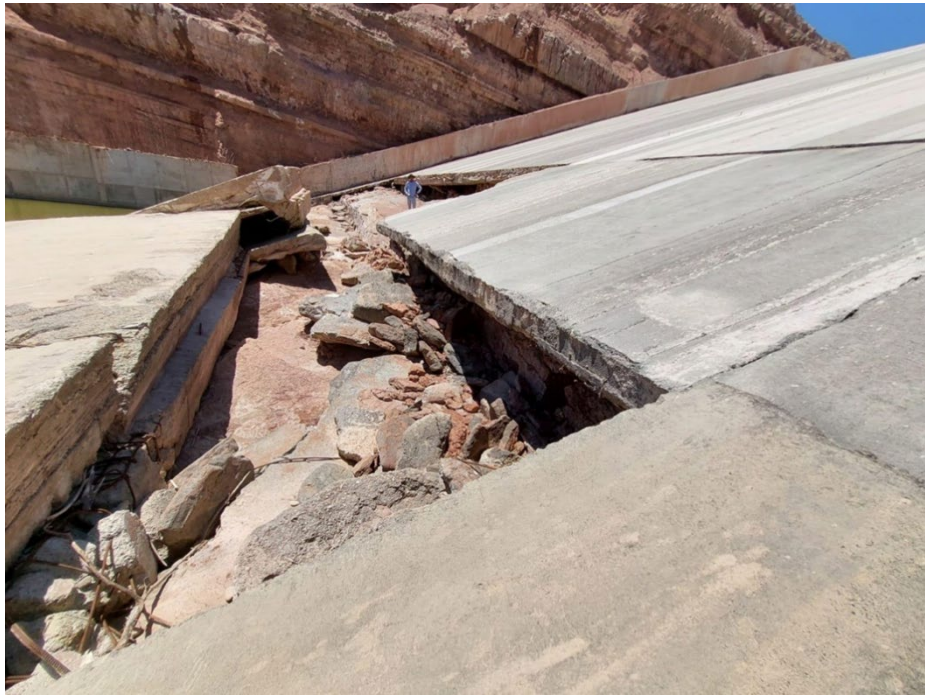
Another cause for the failure of the Dewana Dam spillway was primarily due to its construction on

Figure 11: Poor quality rock beneath the chute slab of the Dewan Dam spillway.
