**Review Article:****The effect of applying (ADA) criteria in designing commercial street sidewalks in the city center of Sulaimaniyah****Hawar Taha Tawfeeq**

University of Sulaimani, College of Engineering, Architecture Department

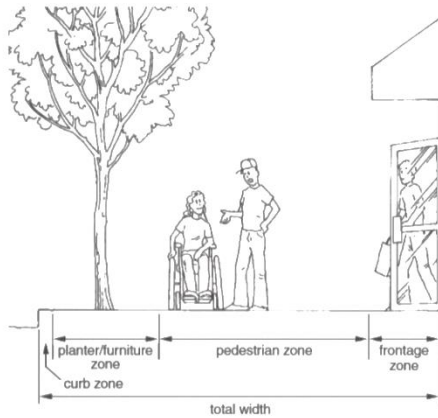
**Fig.1: The zone system divides the sidewalk corridor into four zones to ensure that pedestrians have a sufficient amount of clear space to travel.**  
 (Source: Beneficial Designs, Inc,2001,P4-3)

Generally sidewalks consist of the following zones: the building frontage zone, the pedestrian

zone, the planter/furniture zone, and the curb zone (FHWA, 2001, P7) (Figure 1).

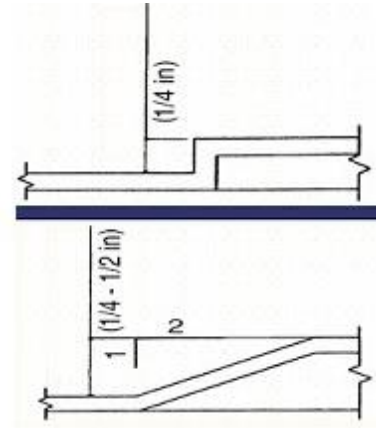
**Fig.2: shows changes in level.**  
 (Source: U.S. Access Board, 2002)

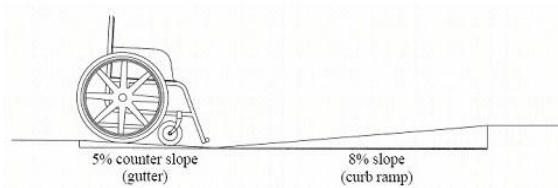
**Fig.3: The gutter slopes counter to the slope of the curb ramp to promote drainage.**  
 (Source: Beneficial Designs, Inc,1999,P33)

The running slope or grade is defined as the slope parallel to the direction of travel, with the running grade defined as the average grade along a continuous grade. The grade of a sidewalk should be as level as possible allowing easy use by travelers. For pedestrian facilities on public access routes, the running grade of sidewalks will be a maximum of 5% (figure 3).

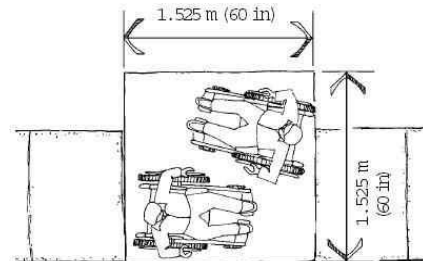
**Fig.4: Passing spaces should be included at intervals on narrow sidewalks to allow wheelchair users to pass one another.**  
 (Source: U.S. Access Board, 2002)

Passing space is defined as a section of path wide enough to allow two wheelchair users to pass one another or travel abreast (Figure 4). The passing space provided should also be designed to allow one wheelchair user to turn in a complete circle. (U.S. Access Board, 2002)

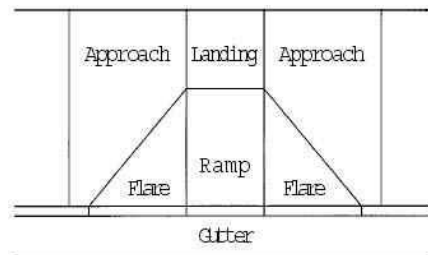
**Fig.6: curb ramp components.**  
 (Source: FHWA,2001,19)

Curb ramp is consisted of the following elements which are Shawn in the (figure 6).

- 1- The ADA curb ramp slope standards require the slope to be no more than a maximum of a 1:12 ratio or 8.33%. Transitions from ramps to walks, gutters, or streets shall be flush and free of abrupt changes. Maximum slopes of adjoining gutters, road surface immediately adjacent to the curb ramp, or accessible route shall not exceed 1:20.

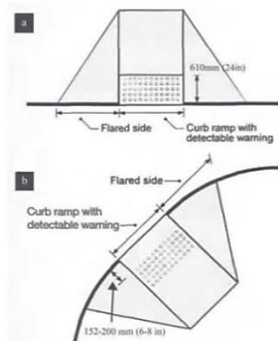
**Fig.7: Curb ramp designs showing 610 mm (24 in) detectable warning.**  
(Source: FHWA,2001,25)

- 4- Built-up curb ramps shall be located so that they do not project into vehicular traffic lanes.
- 5- A curb ramp shall have a detectable warning,(Detectable warnings shall consist of raised truncated domes with a diameter of nominal 0.9 in (23 mm), a height of nominal 0.2 in (5 mm) and a center-to-center spacing of nominal 2.35 in (60 mm) and shall

contrast visually with adjoining surfaces, either light-on-dark, or dark-on-light. Also the detectable warning shall extend the full width and depth of the curb ramp (Figure 7).

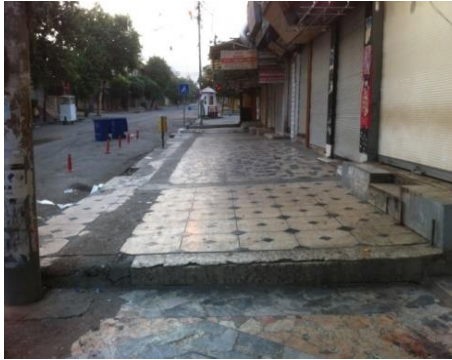
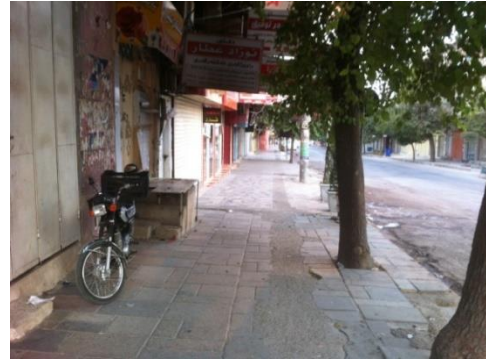
- 2- The outcome analysis of the sidewalk corridor shows that the construction condition for 93% of the sidewalk is poor and damaged due to the presence of potholes, cracking and fractures in the finishing materials and hence the sidewalk cannot be used properly by people with special needs. And 86% of the sidewalks bear/have shade which is a convenient factor for the pedestrians to go through a suitable atmosphere and be protected from hot and cold weather conditions. (Figure 11)

**Fig.11: Construction conditions of the sidewalks.** (Source: Researcher)

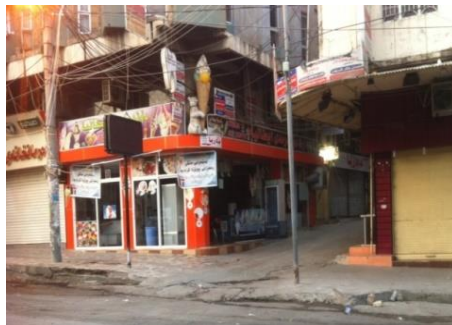
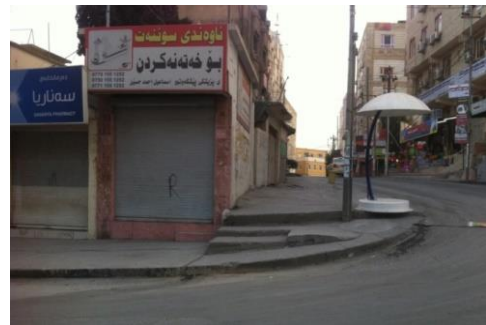
- 3- As for Sidewalk Grade and Cross Slope, the results demonstrate that the range for 64% of the sidewalk is higher than 2% which is more than the required level; however the sloping level is suitable with all the sidewalks and yet no landing can be seen as shown in figure (12).

**Fig.12: Slope and cross slope of the sidewalks.** (Source: Researcher)

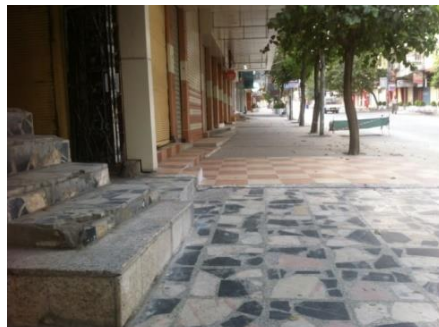
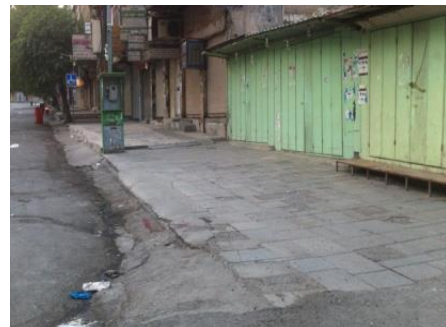
- 4- In all the sidewalks, various materials such as( Tile, concrete, brick, asphalt)in different colors, textures and thickness were used in the finishing of the walkways which made them not to be suitable for use by people with special needs causing obstacles to their wheelchairs and they cannot be identified by visually impaired people. (Figure 13)

**Fig.13: Various materials in different colors, textures and thickness were used in the finishing of the walkways.** (Source: Researcher)

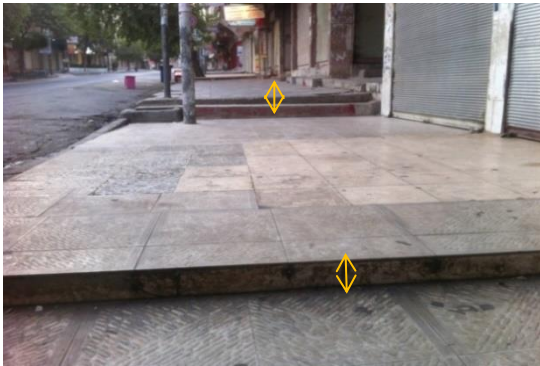
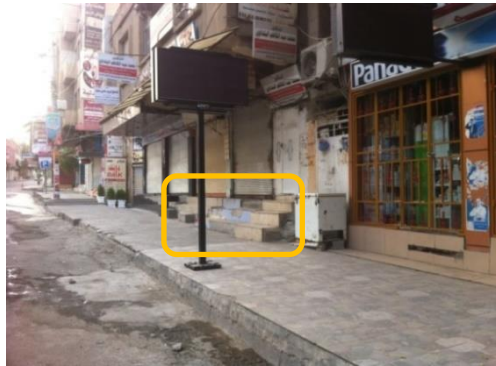
- 5- There are steps in all segments of the sidewalks with different heights and materials. Moreover, they have been constructed in a random manner and there is no any kind of ramps, resulting in creating obstacles for the wheelchairs. (Figure 14)

**Fig.14: The existence of steps into the sidewalks.** (Source: Researcher)

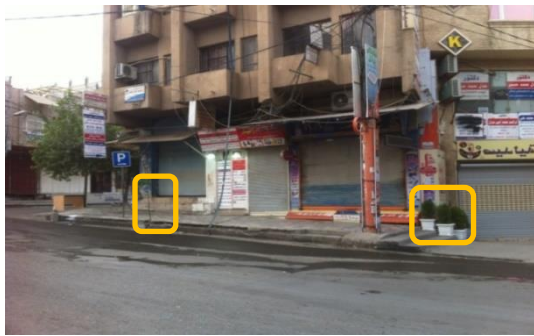
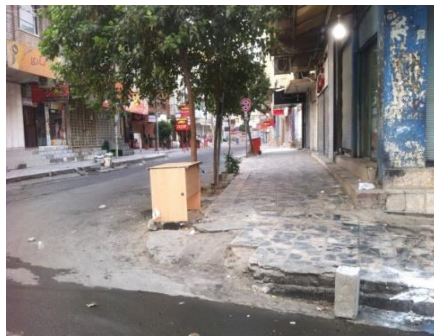
- 6- 50% of the sidewalks (trees, electric poles, and traffic signs) can be seen, and more than half of this percentage does not fall into the planter zone, but they fall into the other parts of the sidewalks and thereby have become obstacles for transportation of people with special needs. Not to mention that there is only one seating place which does not fit into its special zone. Furthermore, in all the parts of the sidewalks in the street, trespassing has been seen onto the sidewalks by the shops or houses or street vendors. (Figure 15).

**Fig.15: The planter zone of the sidewalks in the study area.** (Source: Researcher)

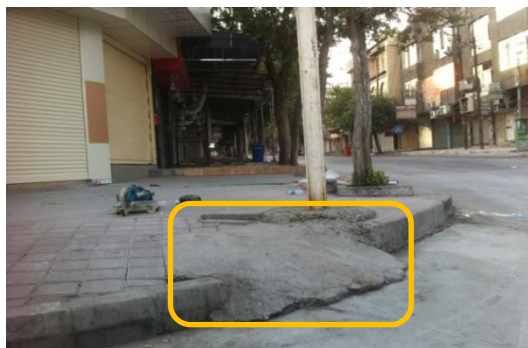
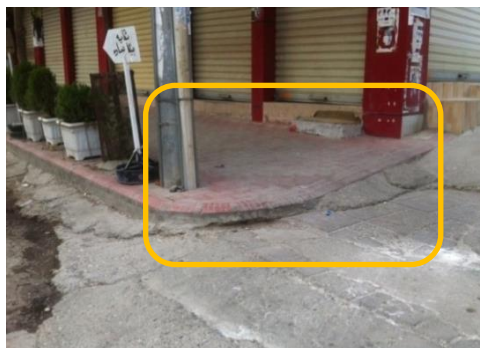
- 8- The driveway slope is compatible for 93% of the sidewalks and so is the cross slope.
- 9- 86% of the sidewalks are not curb ramp which is one of the most important parts of the sidewalk and has special importance for people with special needs (Figure 16). For the remaining 14%, the ramps have not been built to reach the standard and they are close to perpendicular and depressed corner type.

**Fig.16: Lack of standard curb ramp into the sidewalks of the study area** (Source: Researcher)

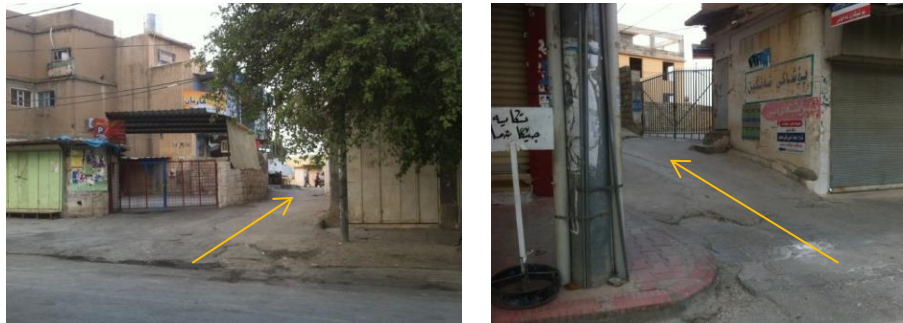
- 11- There is not any pedestrian crossing in any parts of the street which has become a burden for the crossing of people with special needs and sometimes has caused tragic accidents as it's shown in the figure 17.

**Fig.17: The drive way crossing has not been considered into the sidewalks of the study area.** (Source: Researcher)

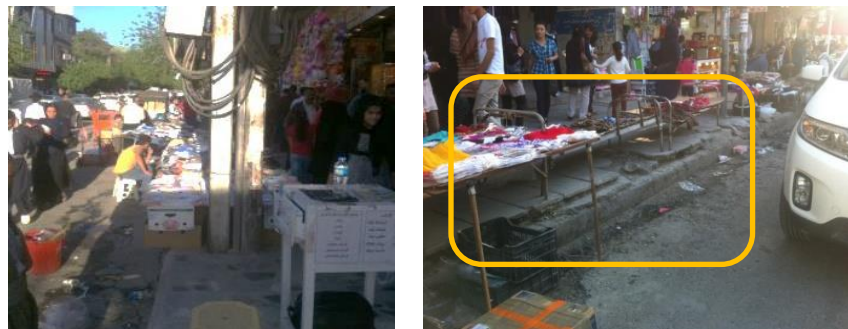
- 12- Trespassing continues to occur on the sidewalks, which are created both temporarily and permanently by the individuals and shop owners, which has narrowed the sidewalk corridors.(Figure 18)

**Fig18: Shows different kinds of Trespassing into the sidewalks.** (Source: The researcher)

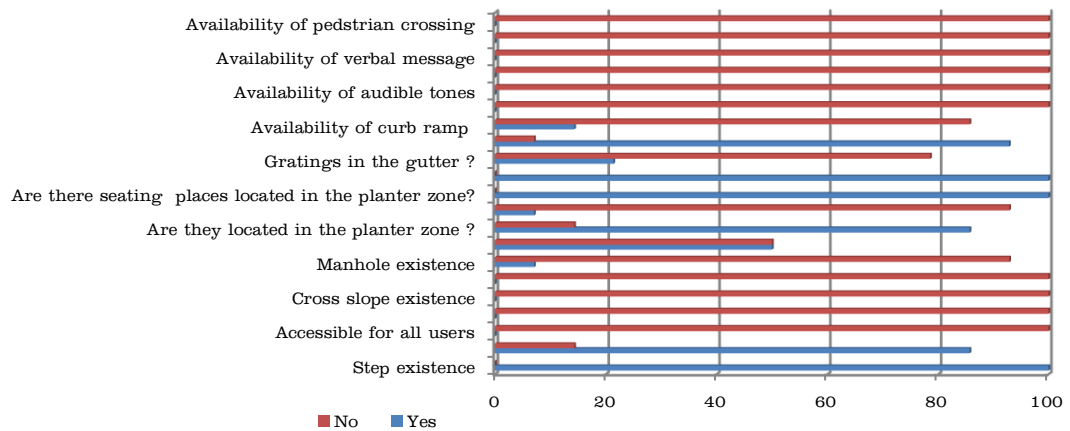
- 15- The results which have been reached from the check lists that applied to all segments of the sidewalk in the study area have shown that most of the necessary regulations have not been considered in this area which makes various problems to the users especially for those who has special needs.(figure 19).

**Fig.19: Check list results.** (Source: Researcher)

- The research recommends the municipality should pay attention to the relevant international criteria especially in the development process and preparation new master plans.
