A comprehensive Analysis of Dewana Dam Spillway Failure: Causes, and Consequences

Avi Ari Salahadin^{1,a,*}

Kawa Zaidan Abdulrahman^{2,a}

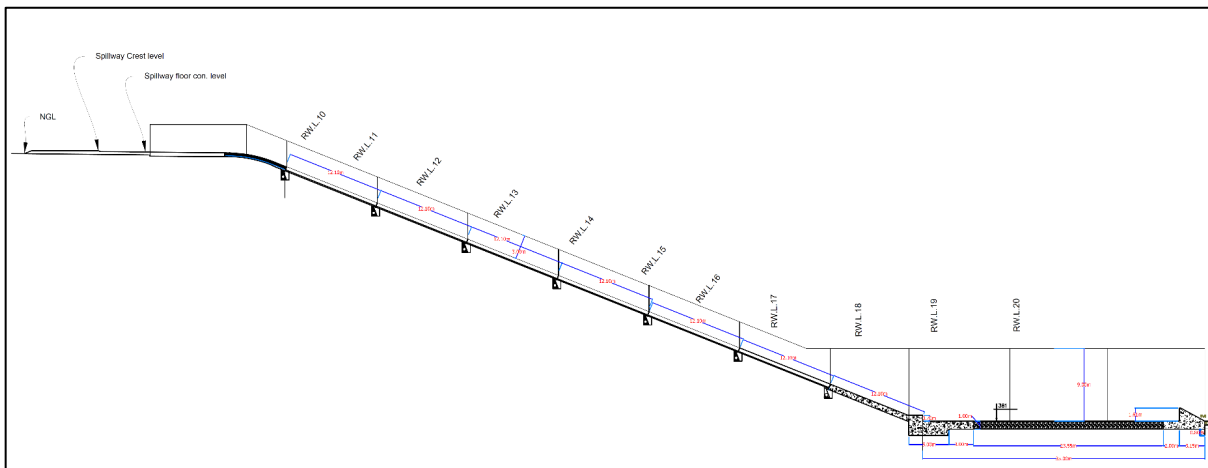
Figure 2:Profile of the Dewana Dam Spillway

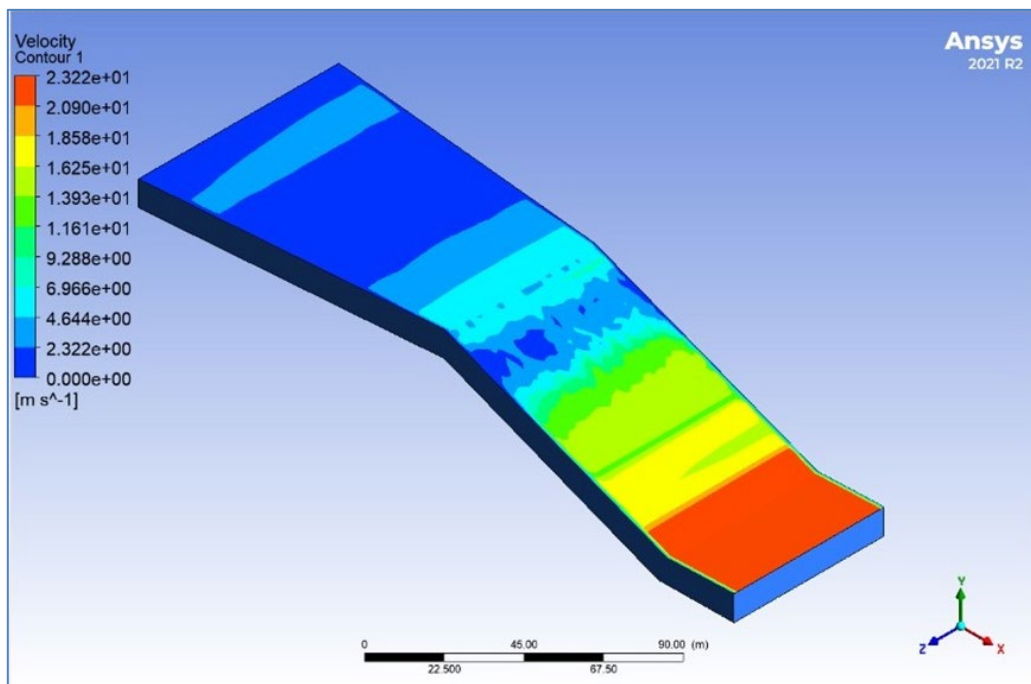
According to the numerical simulation results obtained using ANSYS Fluent, the maximum flow velocity at the downstream end of the spillway chute reached approximately 23 m/s, as illustrated in Figure 6. To assess the potential for cavitation-related damage, a detailed site inspection was conducted in conjunction with hydraulic analysis. Observations did not reveal typical signs of cavitation-induced distress such as pitting or surface degradation. Based on the simulated velocity

Figure 6: The Results of the ANSYS Software
